CASE STUDY

EnviroROCK® 3PL composite geosynthetic soft wrapped-wall coastal erosion protection system

Oct 2017

Client Situ Island Resort

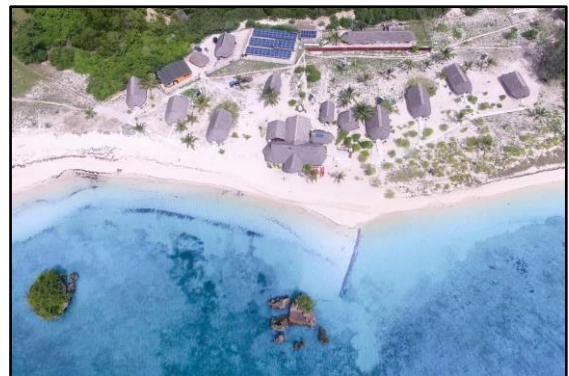
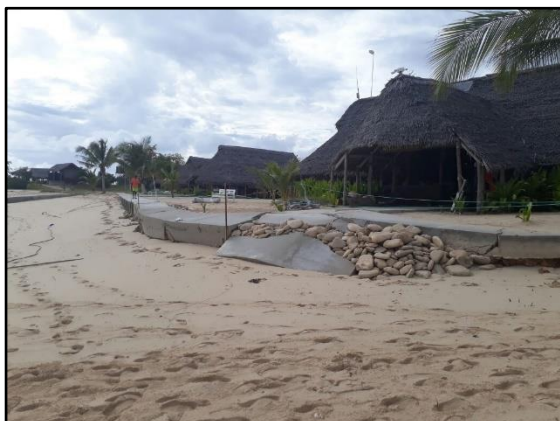
The beach was slowly being eroded by strong currents resulting from a spring tide that ranges up to 4m. The concrete walkway was undermined and had collapsed forward towards the sea. Efforts were made to reinstate the walkway using round boulders, but material was limited as all rock had to be brought in by boat from the mainland. The resort needed another solution that would limit the requirement of imported materials. EnviroROCK® 3PL geocontainers provided the ideal solution as they are sand-filled and sand is abundant on the island. However, there are no roads or vehicles on the island, so filling and placing the 3 ton EnviroROCK® 3PL geocontainers was not possible. Another solution was required.

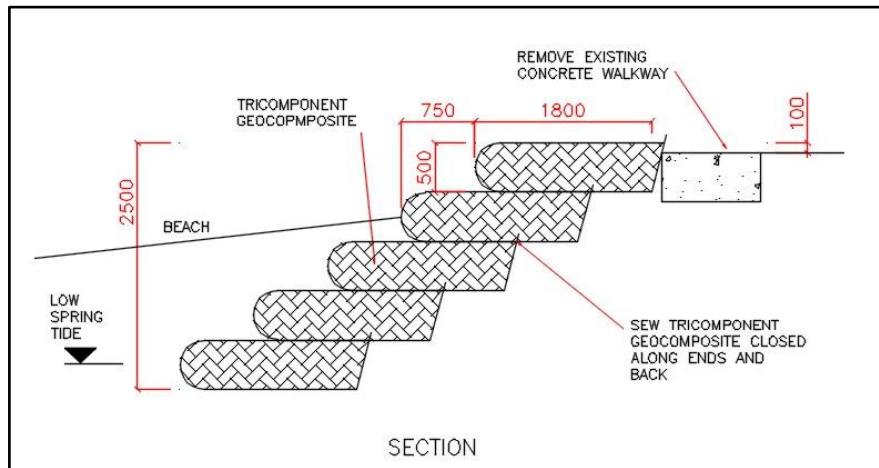
Typical section of EnviroROCK® 3PL geo-tube system

The answer was to construct the EnviroROCK® 3PL geocontainers in-situ, using hand labour only. The EnviroROCK® 3PL wrapped-wall system consisted of 5 layers, 500mm thick to a height of 2.5m. EnviroROCK® 3PL was supplied in 4.6m wide by 50m rolls. Each layer was set back 750mm with a width of 1.8m. EnviroROCK® 3PL was hand-sewn closed along the edges and the back. Using a soldering iron, holes were burned 25mm from the edge at 25mm c/c for the sewing closure, creating long geocontainers. EnviroROCK® 3PL geocomposite was preferred for this system to ensure the holes formed for sewing do not stretch open under load. The final location of the EnviroROCK® 3PL sea wall was marked out, using long bamboo survey poles.

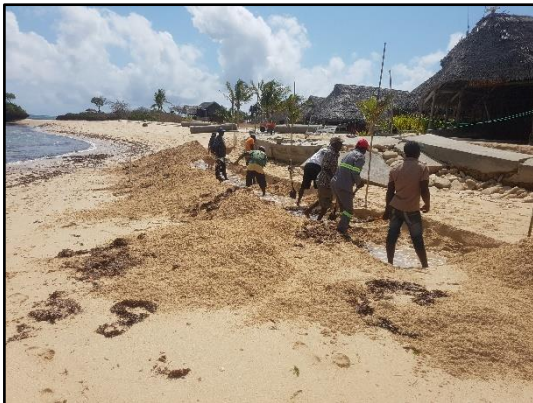
Excavation of foundation

A 1.8m wide by 50m long foundation was excavated to low spring level during the dropping tide, EnviroROCK® 3PL placed into position and rapidly filled by spade and wheelbarrow. This was water compacted before pulling the EnviroROCK® 3PL geocomposite cover layer over and hand-sewn along the sides and back. All work had to be completed 3 hours before the high tide. Subsequent layers were then contained within a frontal formwork. The rear of the structure was sand-filled to level, providing support for the formwork. However, this was not possible along the sea-facing frontage. Vertical stakes were not feasible as formwork supports as the EnviroROCK® 3PL tubes were set back, overlying the EnviroROCK® 3PL tubes beneath. There was also insufficient support within the soft saturated sand to accommodate long props placed along the sloping beach in front of the EnviroROCK® structure. The solution was to use support brackets with an underlying long flat section, placed at regular intervals between the overlying and underlying EnviroROCK® 3PL tubes. These were easily pulled out once the EnviroROCK® 3PL geocontainer had been filled and sewn closed.

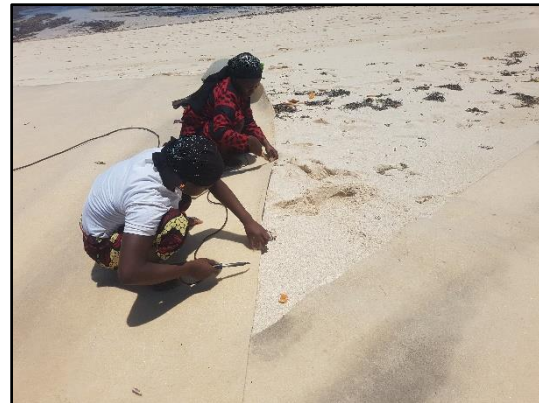
making holes for stitching

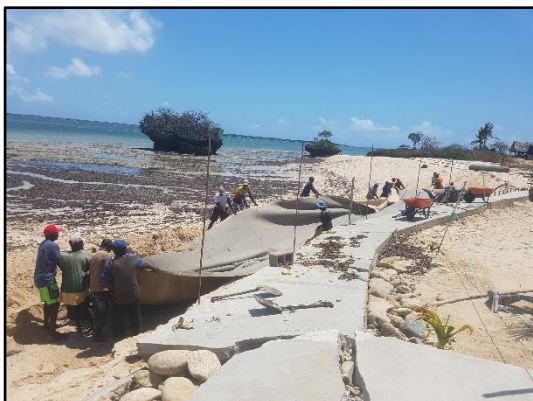
Placing of EnviroRock 3PL in position

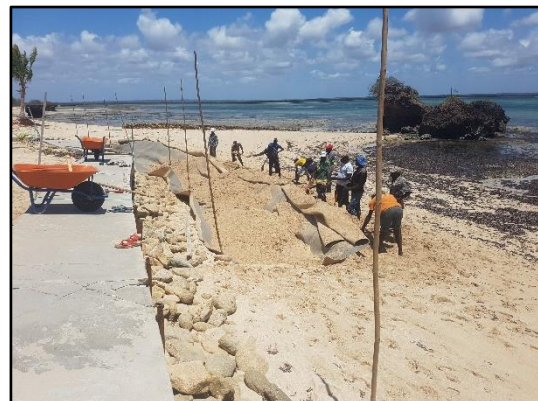
hand filling tubes

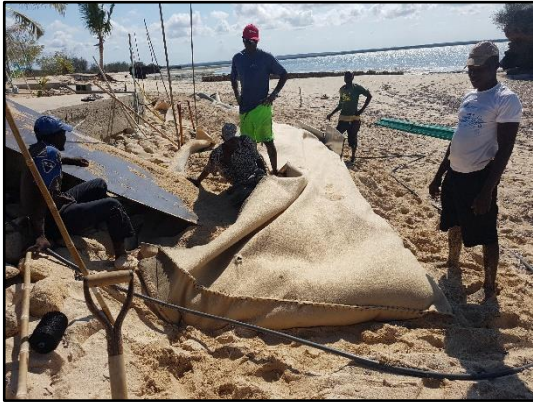
sewing the back closed

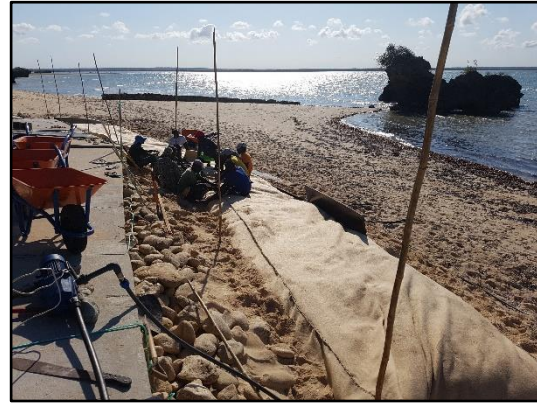
Sewing edges and filling corners

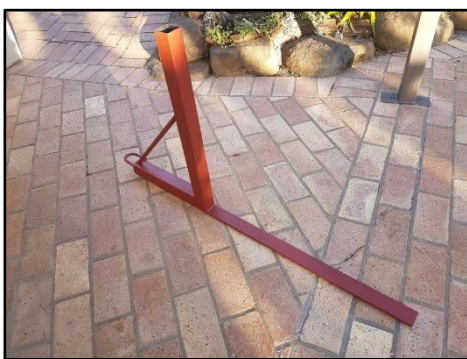
Formwork support brackets

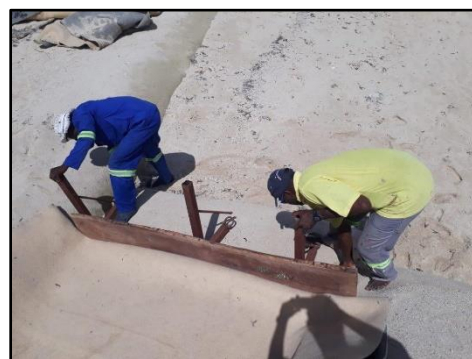
Placing formwork and brackets under EnviroROCK®

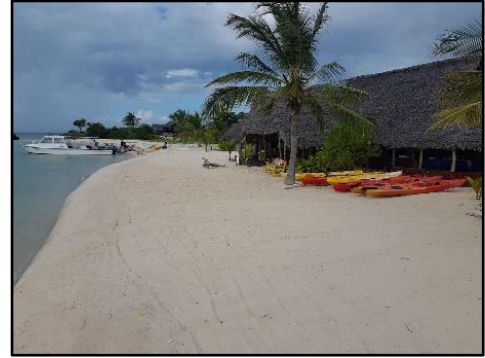
The final finish is multiple layers of a nonwoven, coarse, beige, soft, rounded tubes. The coarse outer layer of EnviroROCK® 3PL entraps 2 to 3 kg sand/m² for added UV and damage protection. The system is flexible and blends into the natural features of the coastal environment. Wave energy is absorbed; minimising scour and wave bounce back, which is a threat to beach users. EnviroROCK® 3PL is not affected by pedestrian traffic and provides a soft, but firm structure for seating. The system has performed above expectations and in July 2020 the shareholders extended the seawall using the same technique. 7 years later the distinct line of protection can be clearly seen on Google Earth, while on the ground it is barely visible as a bump in the sand.
